Badger Coulee 345 kV Transmission Line Project Construction and Mitigation Plan (CMP) Segment 4

CONSTRUCTION and MITIGATION PLAN

Badger Coulee 345 kV Transmission Line Project - Segment 4

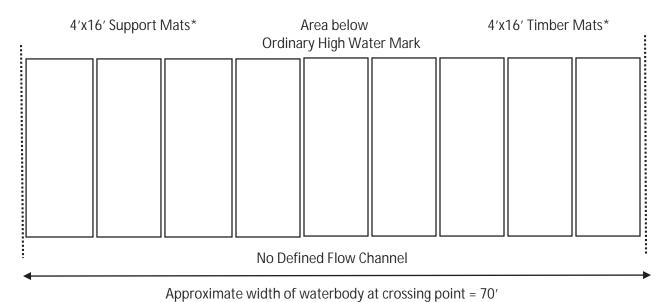
Plan View

4'x16' Timber Mats are below OHWM

Depth of Water = 6'' - 1' (Observed to be seasonally dry) Clearance to Water = Mats will be set on bed of waterbody

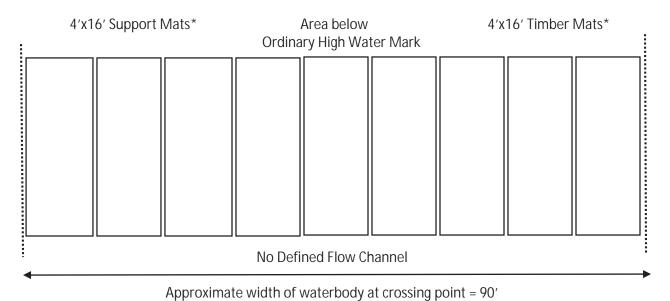
Plan View

4'x16' Timber Mats are below OHWM

Depth of Water = 6'' - 1' (Observed to be seasonally dry) Clearance to Water = Mats will be set on bed of waterbody

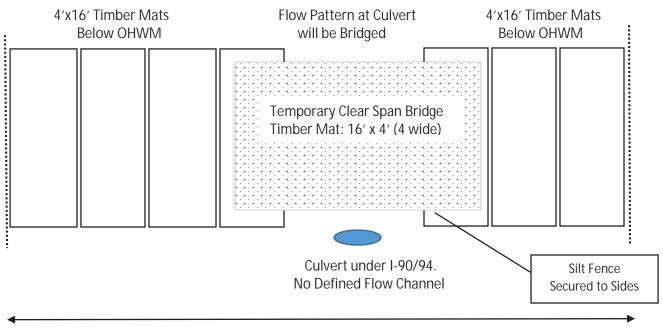
Plan View

Approximate width of waterbody at crossing point = 70'

Depth of Water = 6'' - 1' (Observed to be seasonally dry) Clearance to Water = Mats will be set on bed of waterbody

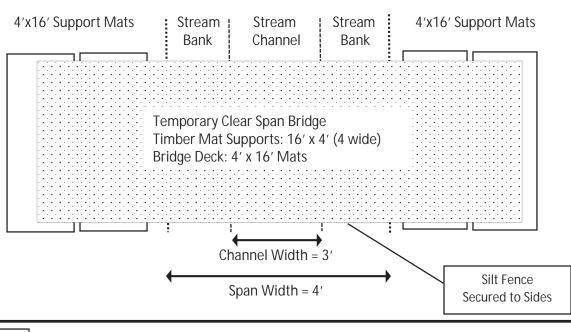
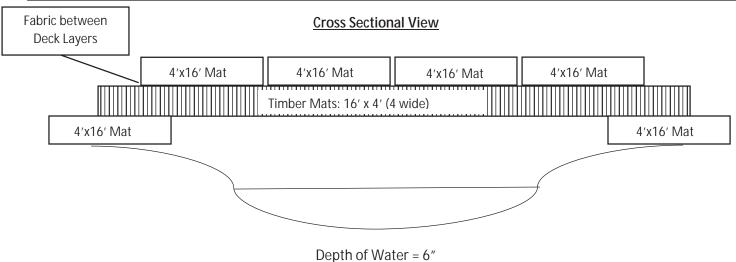
Plan View

- Drawings are not to scale
- TCSB will be secured to a fixed anchor
- Sediment Controls: Silt fence shall be attached to the bridge sides and fabric laid between the deck layers.

Clearance to Water = 2'

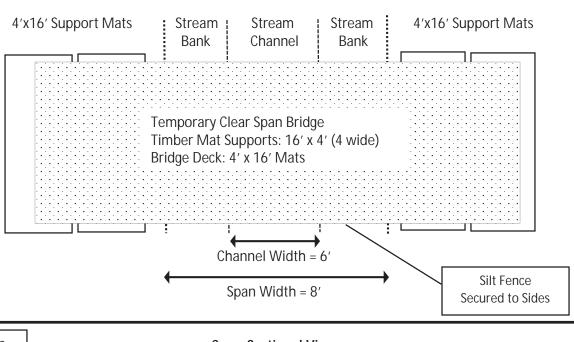
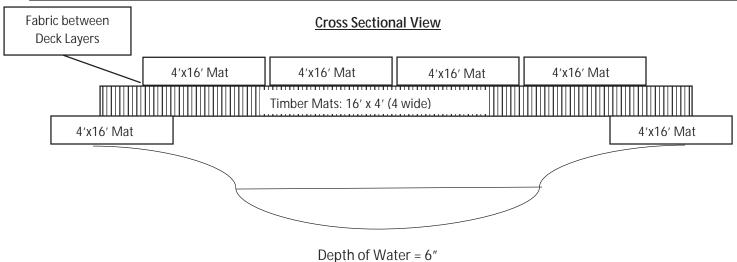
Plan View

- Drawings are not to scale
- TCSB will be secured to a fixed anchor
- Sediment Controls: Silt fence shall be attached to the bridge sides and fabric laid between the deck layers.

Clearance to Water = 2'

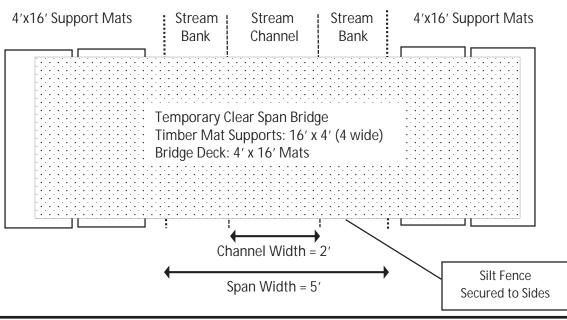
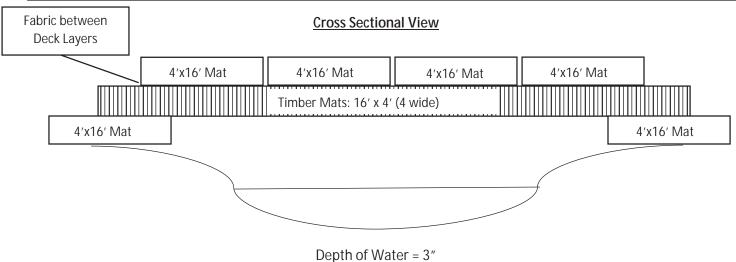
Plan View

- Drawings are not to scale
- TCSB will be secured to a fixed anchor
- Sediment Controls: Silt fence shall be attached to the bridge sides and fabric laid between the deck layers.

Clearance to Water = 1'

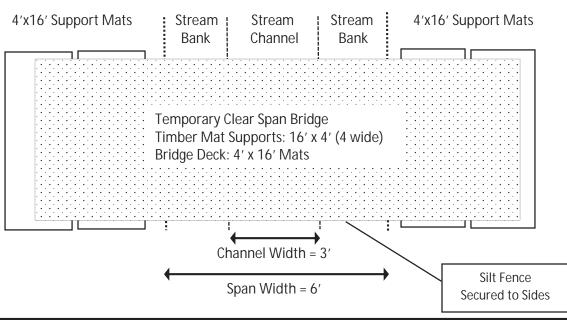
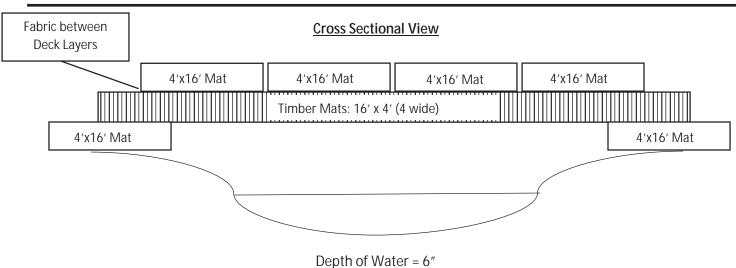
Plan View

- Drawings are not to scale
- TCSB will be secured to a fixed anchor
- Sediment Controls: Silt fence shall be attached to the bridge sides and fabric laid between the deck layers.

Clearance to Water = 1'

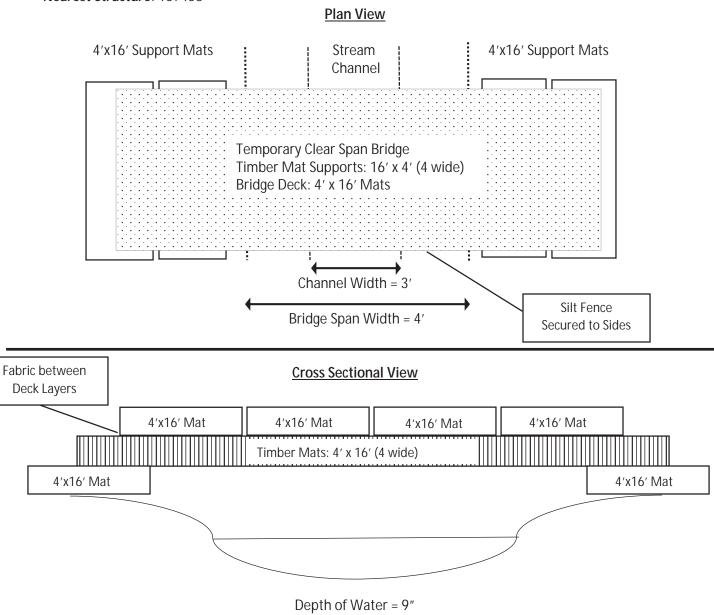
Segment: 4 Waterway: N-R89

- Drawings are not to scale
- TCSB will be secured to a fixed anchor
- Sediment Controls: Silt fence shall be attached to the bridge sides and fabric laid between the deck layers.

Clearance to Water = 2'

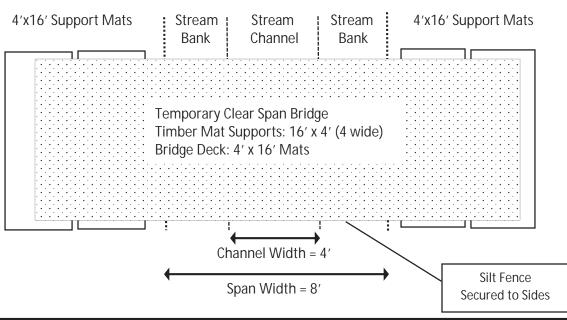
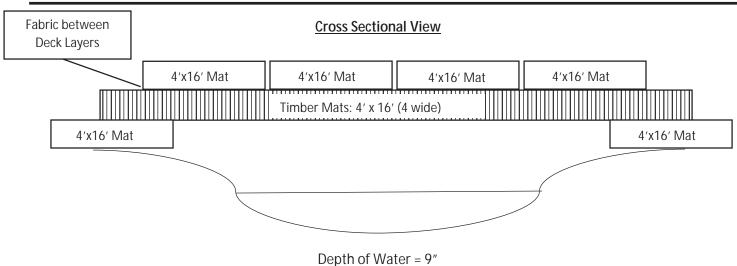
Plan View

- Drawings are not to scale
- TCSB will be secured to a fixed anchor
- Sediment Controls: Silt fence shall be attached to the bridge sides and fabric laid between the deck layers.

Clearance to Water = 1'

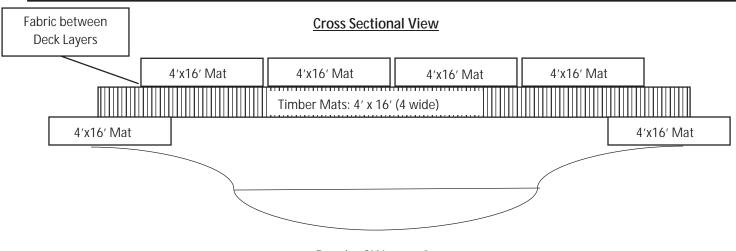
Plan View

Depth of Water = 9" Clearance to Water = 2'

- Drawings are not to scale
- TCSB will be secured to a fixed anchor
- Sediment Controls: Silt fence shall be attached to the bridge sides and fabric laid between the deck layers.

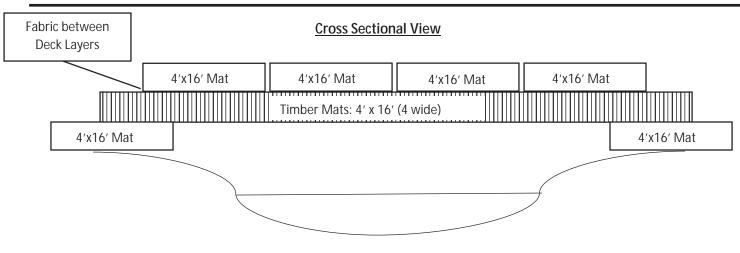
Plan View

Depth of Water = 6" Clearance to Water = 2'

- Drawings are not to scale
- TCSB will be secured to a fixed anchor
- Sediment Controls: Silt fence shall be attached to the bridge sides and fabric laid between the deck layers.

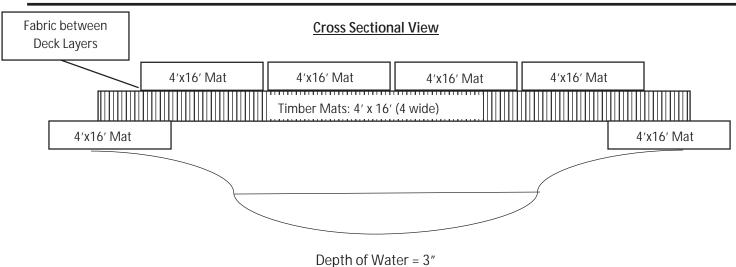
Plan View

- Drawings are not to scale
- TCSB will be secured to a fixed anchor
- Sediment Controls: Silt fence shall be attached to the bridge sides and fabric laid between the deck layers.

Clearance to Water = 1'

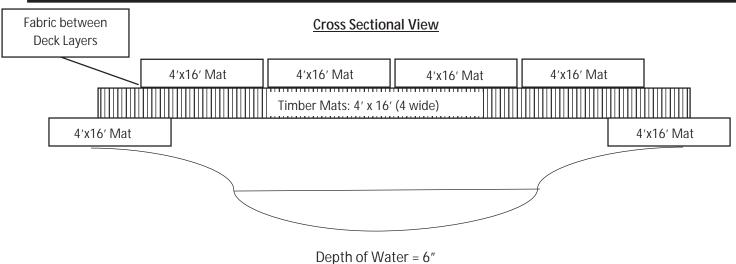
Plan View

- Drawings are not to scale
- TCSB will be secured to a fixed anchor
- Sediment Controls: Silt fence shall be attached to the bridge sides and fabric laid between the deck layers.

Clearance to Water = 3'

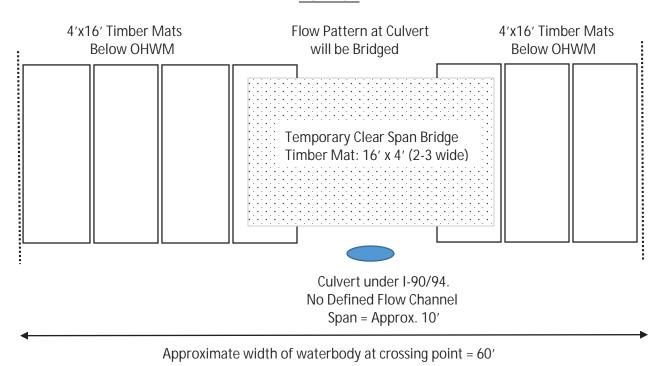
Plan View

4'x16' Timber Mats are below OHWM

Depth of Water = 6'' - 1' (Observed to be seasonally dry) Clearance to Water = Mats will be set on bed of waterbody
