CONSTRUCTION and MITIGATION PLAN

Badger Coulee 345 kV Transmission Line Project – Segment 3 and Northern Portion of Segment 2

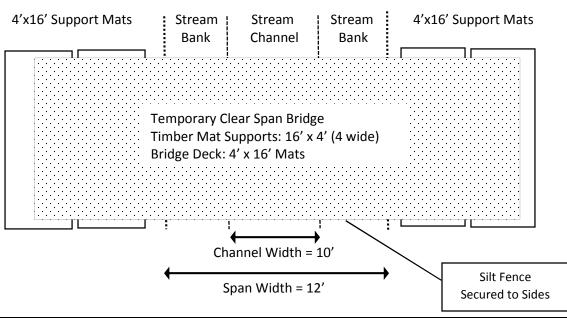
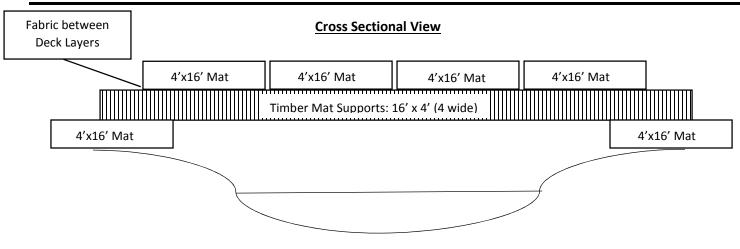
Nearest Structure: 137519

Depth of Water = 18" Clearance to Water = 2'

- Drawings are not to scale
- TCSB will be secured to a fixed anchor
- Sediment Controls: Silt fence shall be attached to the bridge sides and fabric laid between the deck layers.

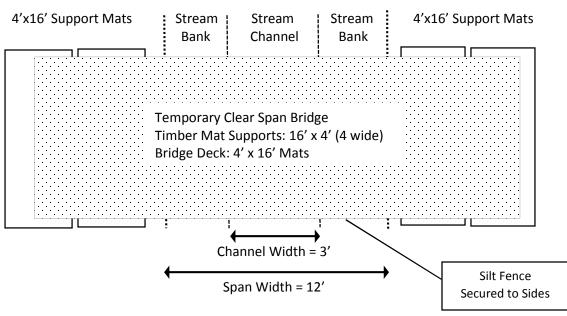
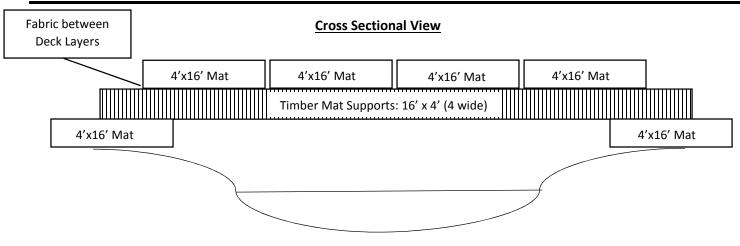
Nearest Structure: 137525

Depth of Water = 9" Clearance to Water = 4'

- Drawings are not to scale
- TCSB will be secured to a fixed anchor
- Sediment Controls: Silt fence shall be attached to the bridge sides and fabric laid between the deck layers.

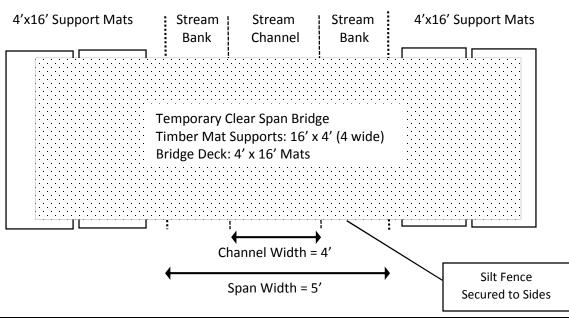
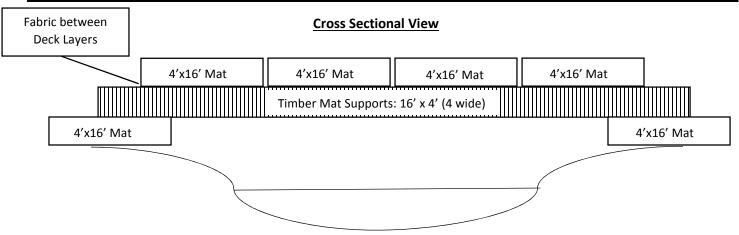
Nearest Structure: 137533

Depth of Water = No Water Clearance to Water = 3'

- Drawings are not to scale
- TCSB will be secured to a fixed anchor
- Sediment Controls: Silt fence shall be attached to the bridge sides and fabric laid between the deck layers.

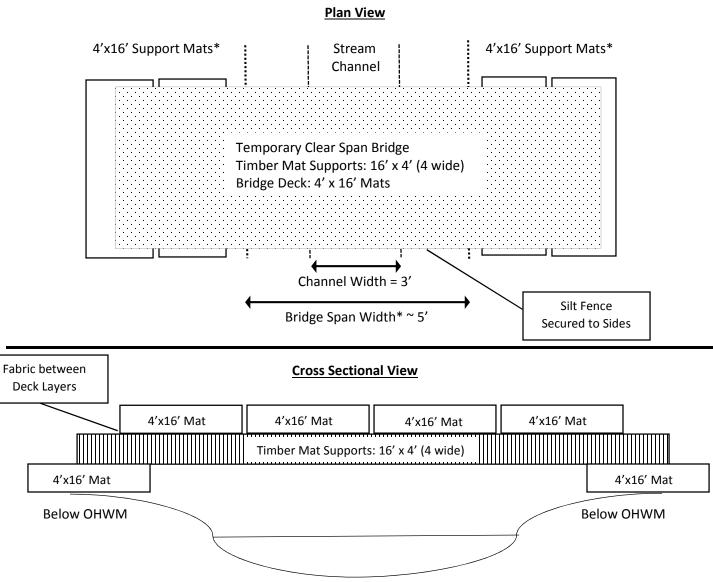
Segment: 3 **Waterway**: H-R5a

- Drawings are not to scale
- TCSB will be secured to a fixed anchor
- Sediment Controls: Silt fence shall be attached to the bridge sides and fabric laid between the deck layers.

Depth of Water = 6" Clearance to Water = 2'

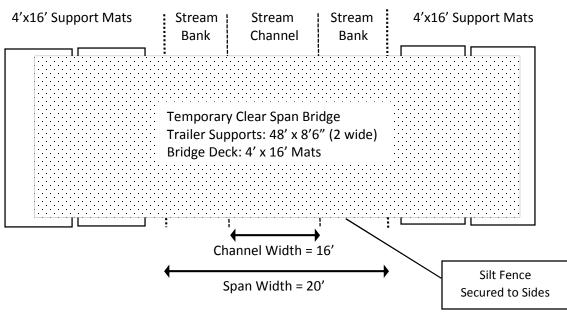
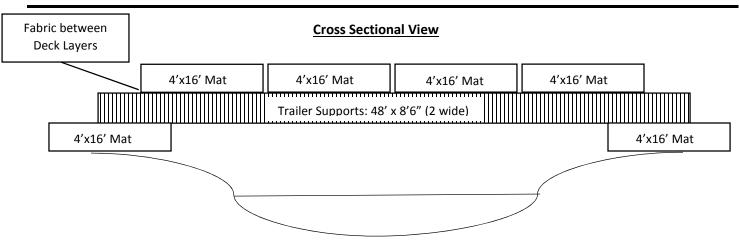
Nearest Structure: 137579-137580

Depth of Water = 2' Clearance to Water = 2'

- Drawings are not to scale
- TCSB will be secured to a fixed anchor
- Sediment Controls: Silt fence shall be attached to the bridge sides and fabric laid between the deck layers.

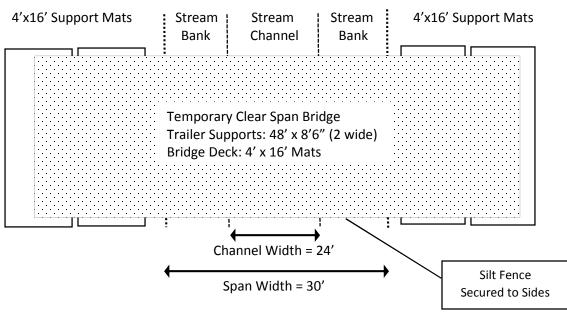
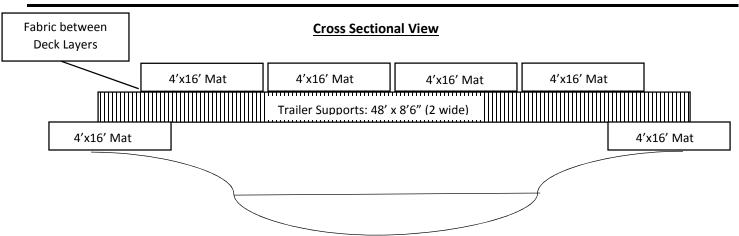
Nearest Structure: 137618

Depth of Water = No Water Clearance to Water = 6'

- Drawings are not to scale
- TCSB will be secured to a fixed anchor
- Sediment Controls: Silt fence shall be attached to the bridge sides and fabric laid between the deck layers.
