CONSTRUCTION and MITIGATION PLAN

Badger Coulee 345 kV Transmission Line Project – Segment 6

American Transmission Company LLC, by its corporate manager, ATC Management Inc. (ATC); Dairyland Power Cooperative (DPC); Northern States Power Company, a Wisconsin corporation (NSPW); SMMPA Wisconsin, LLC (SMMPA Wisconsin), and WPPI Energy (WPPI) (the Applicants) were granted a Ch. 30.025 utility permit by the Wisconsin Department of Natural Resources (WDNR) for work in and adjacent to wetlands and waterways for the Badger Coulee 345 kV Transmission Line Project (Permit #IP-WC/SC-2015-N20001 through N20273)(Attachment 3). This permit requires the Applicants prepare a Construction and Mitigation Plan (CMP) for work in wetlands and waterways for WDNR approval prior to beginning work in these features (General Conditions #9 and 11). As the Project Construction Manager, ATC has prepared this CMP for Segment 6, which outlines construction methods and procedures that will be followed to reduce impacts to these features. Segment 6 is located in Monroe and Jackson Counties and is 29.9 miles long.

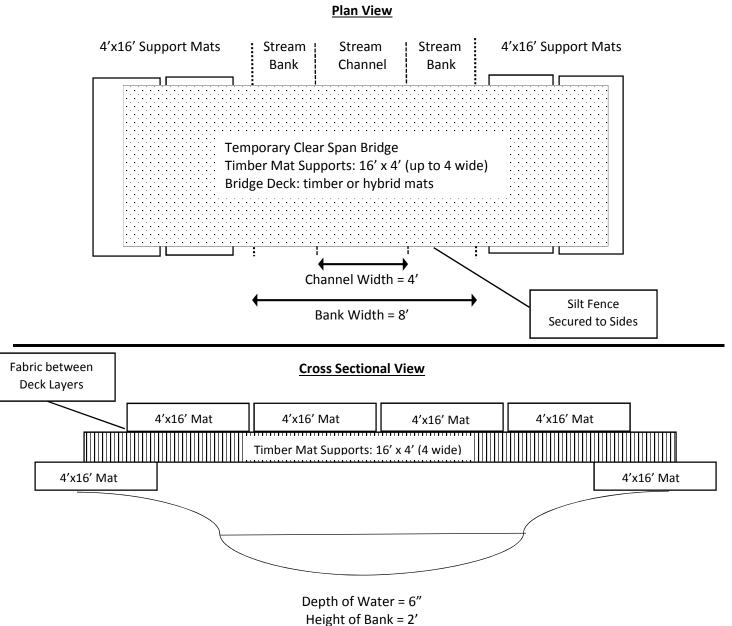
Segment: 6 Waterway: N-R34 Nearest Structure: 137082

- Drawings are not to scale
- TCSB will be secured to a fixed anchor
- Sediment Controls: Silt fence shall be attached to the bridge sides and fabric laid between the deck layers.

As discussed above, up to seven TCSB crossings will be required along Segment 6. Final plan and crosssectional view drawings for each bridge crossing are provided in Appendix D. As required in General Condition #51 of the utility permit, the TCSBs will incorporate measures to reduce soil reaching the waterways.

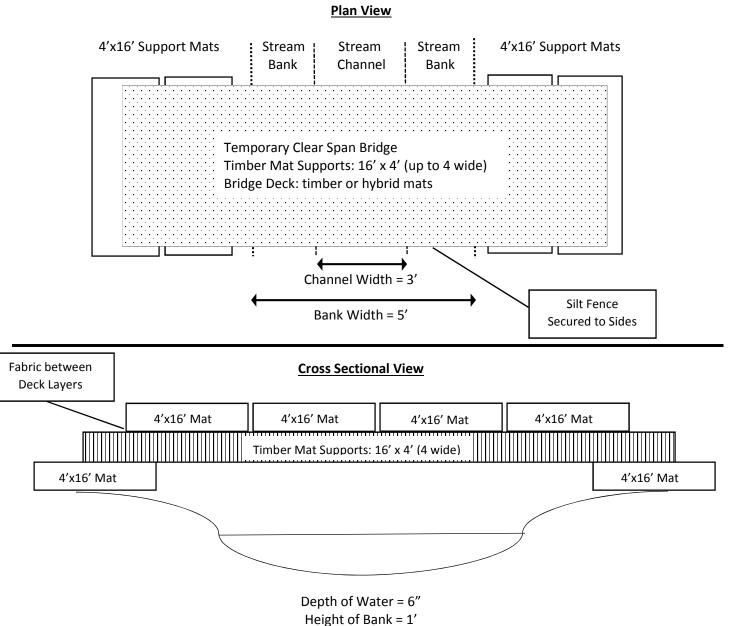
Segment: 6 Waterway: N-R35 Nearest Structure: 137093

- Drawings are not to scale
- TCSB will be secured to a fixed anchor
- Sediment Controls: Silt fence shall be attached to the bridge sides and fabric laid between the deck layers.

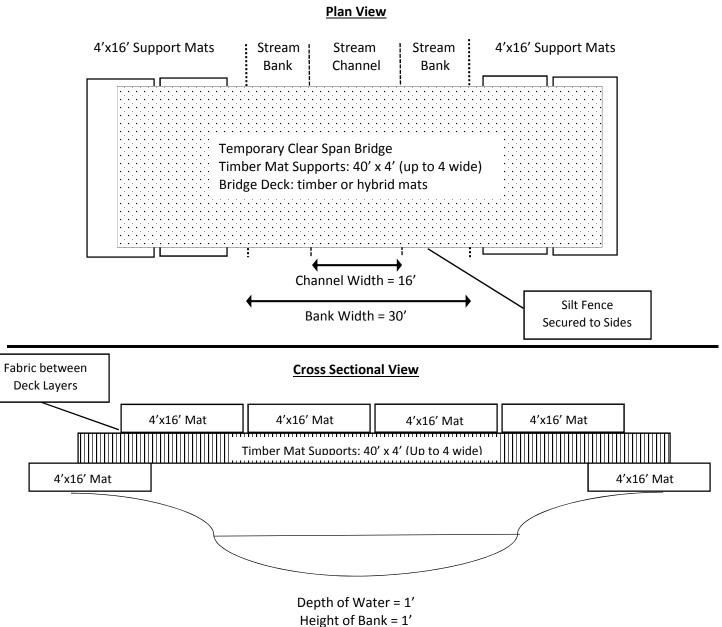
Segment: 6 Waterway: N-R41 Nearest Structure: 137162

- Drawings are not to scale
- TCSB will be secured to a fixed anchor
- Sediment Controls: Silt fence shall be attached to the bridge sides and fabric laid between the deck layers.

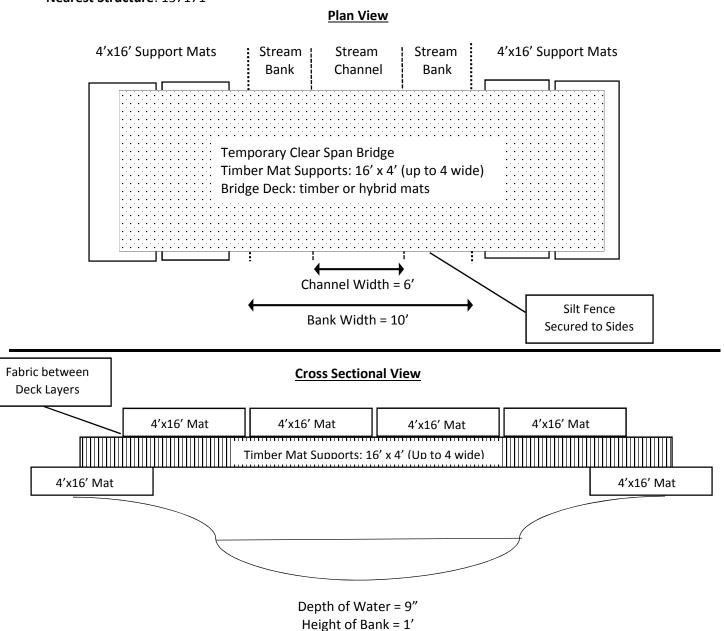
Segment: 6 Waterway: N-R42 Nearest Structure: 137171

- Drawings are not to scale
- TCSB will be secured to a fixed anchor
- Sediment Controls: Silt fence shall be attached to the bridge sides and fabric laid between the deck layers.

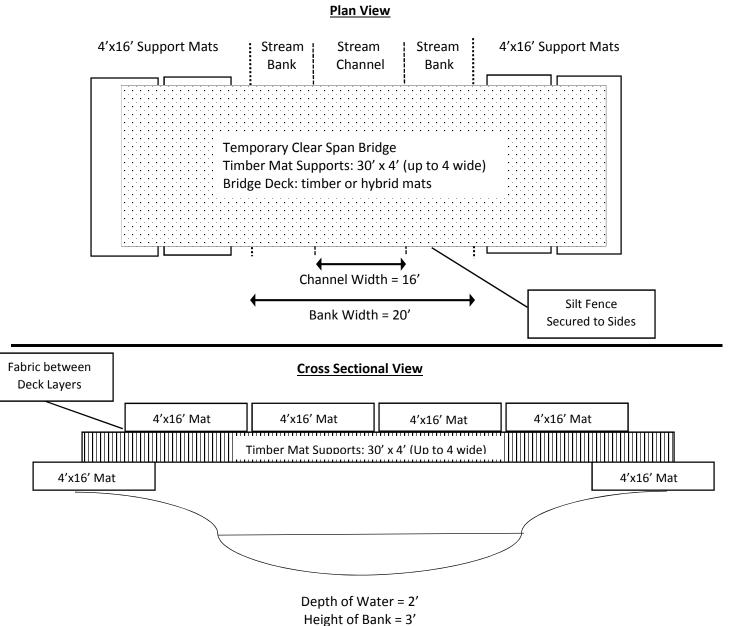
Segment: 6 Waterway: N-R44 Nearest Structure: 137226

- Drawings are not to scale
- TCSB will be secured to a fixed anchor
- Sediment Controls: Silt fence shall be attached to the bridge sides and fabric laid between the deck layers.

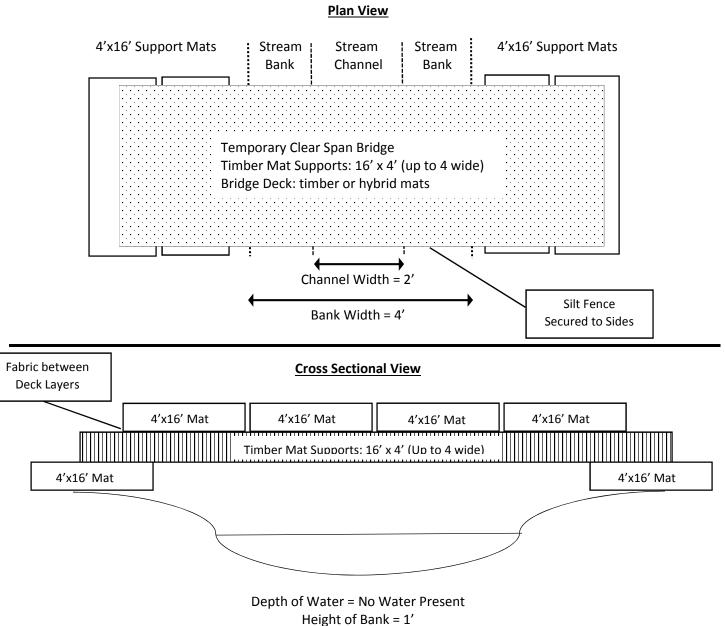
Segment: 6 Waterway: N-R45 Nearest Structure: 137238

- Drawings are not to scale
- TCSB will be secured to a fixed anchor
- Sediment Controls: Silt fence shall be attached to the bridge sides and fabric laid between the deck layers.
